HOUSATONIC RIVER BASIN

EUREKA LAKE DAM

CT 00077

PHASE I INSPECTION REPORT

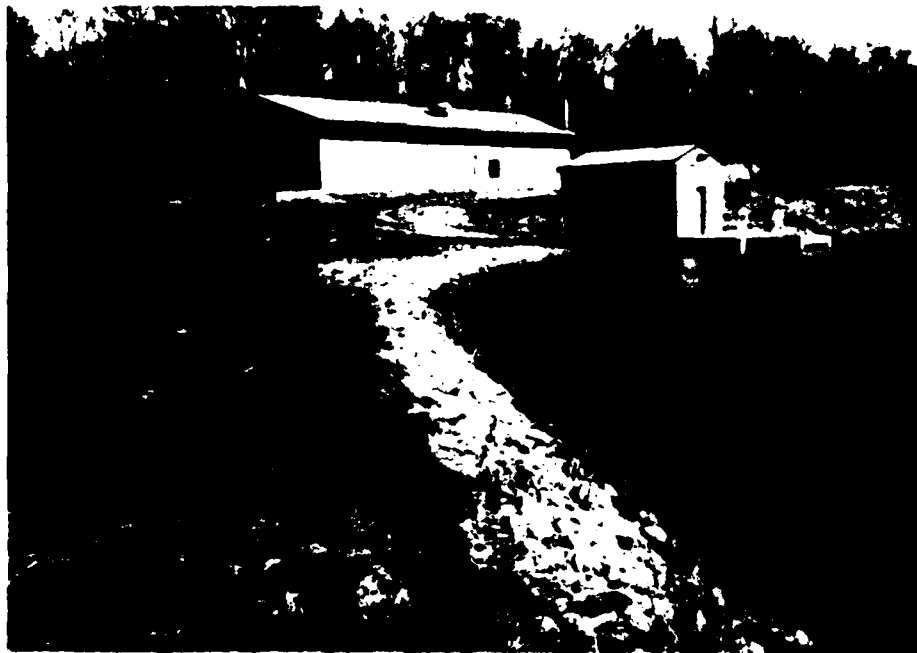
Crest - The crest of the dam has a grass and weed cover. No misalignment, visible depressions or cracks were observed (Photo 1).

Upstream Slope - The slope protection is hand-placed riprap which did not have any visible displacements or areas needing replacement, although there is some vegetation between the stones (Photo 1).

Photo 1 - Crest and upstream slope of reservoir dam from left end
(May 1979)

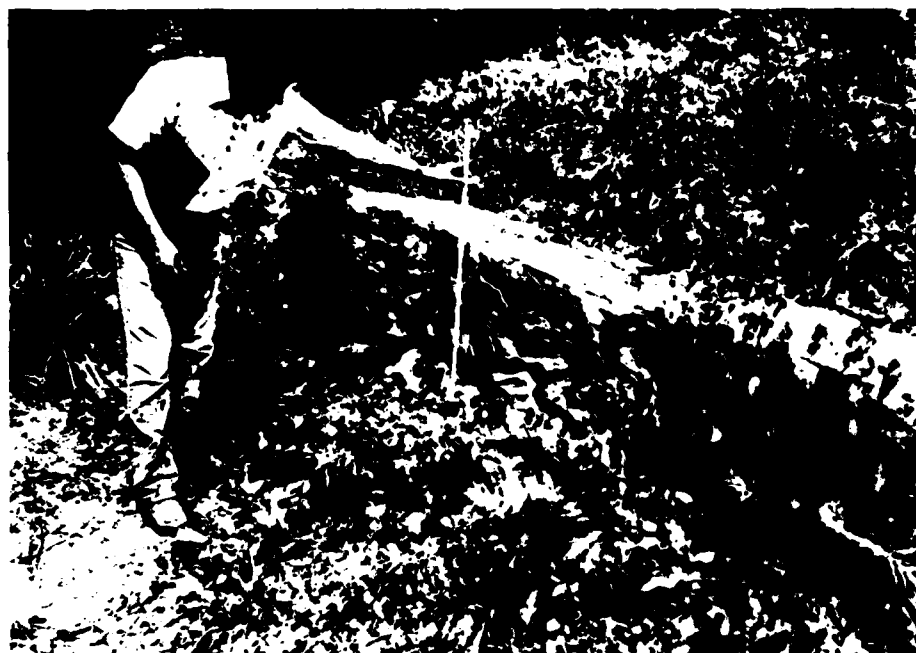
Photo 8 - Masonry training wall of spillway channel from upstream. Note large crack at base of wall (August 1979)
